Dowel Bar Retrofit

Linda M. Pierce, PE
State Pavement Engineer
Washington State Department of Transportation

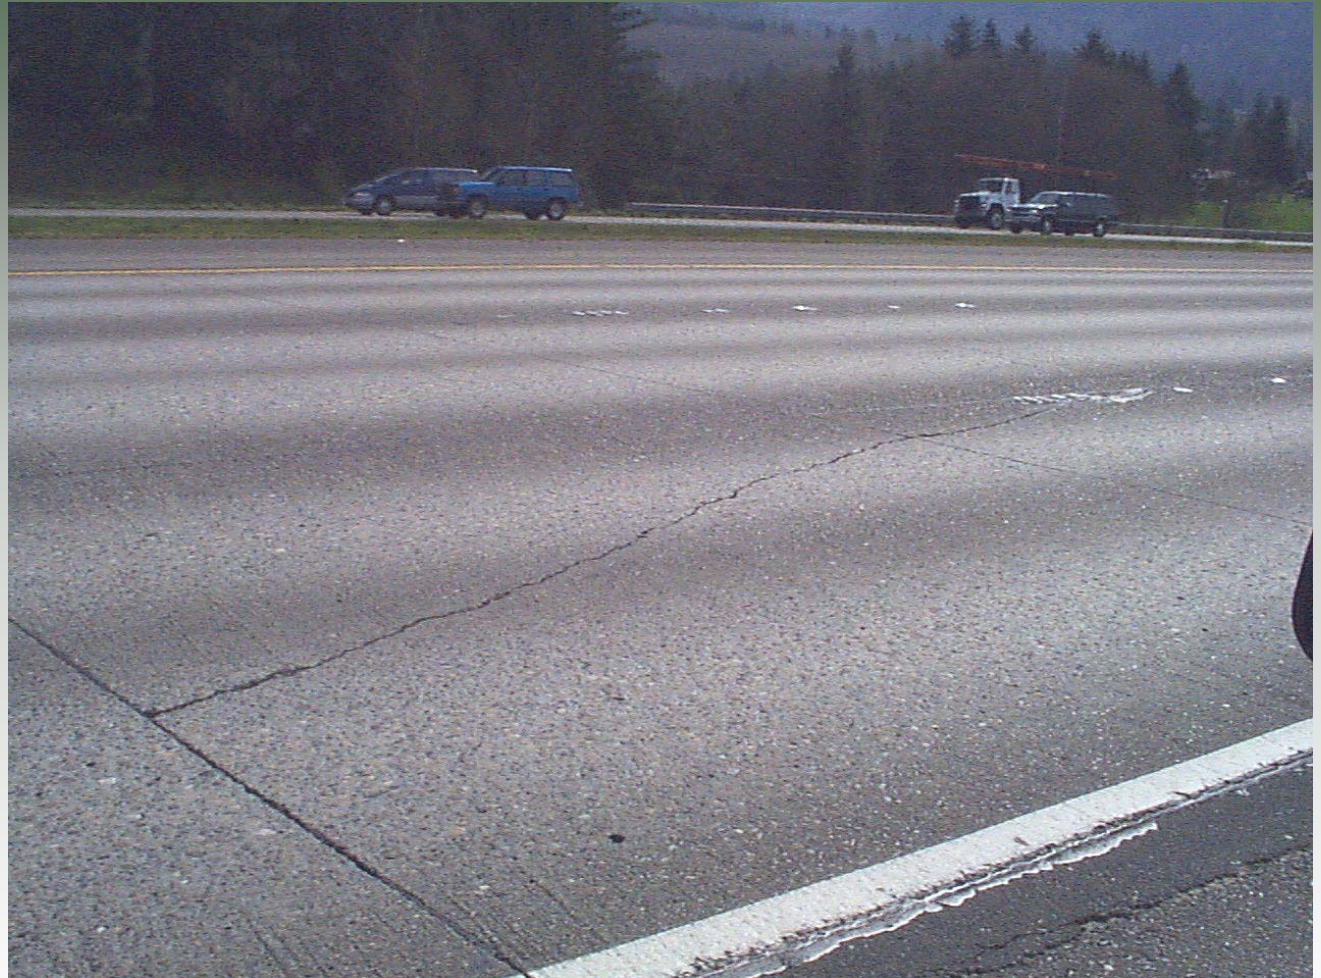
Longitudinal Cracking

- traffic load fatigue
- late sawing
- shallow saw cuts
- use of plastic inserts

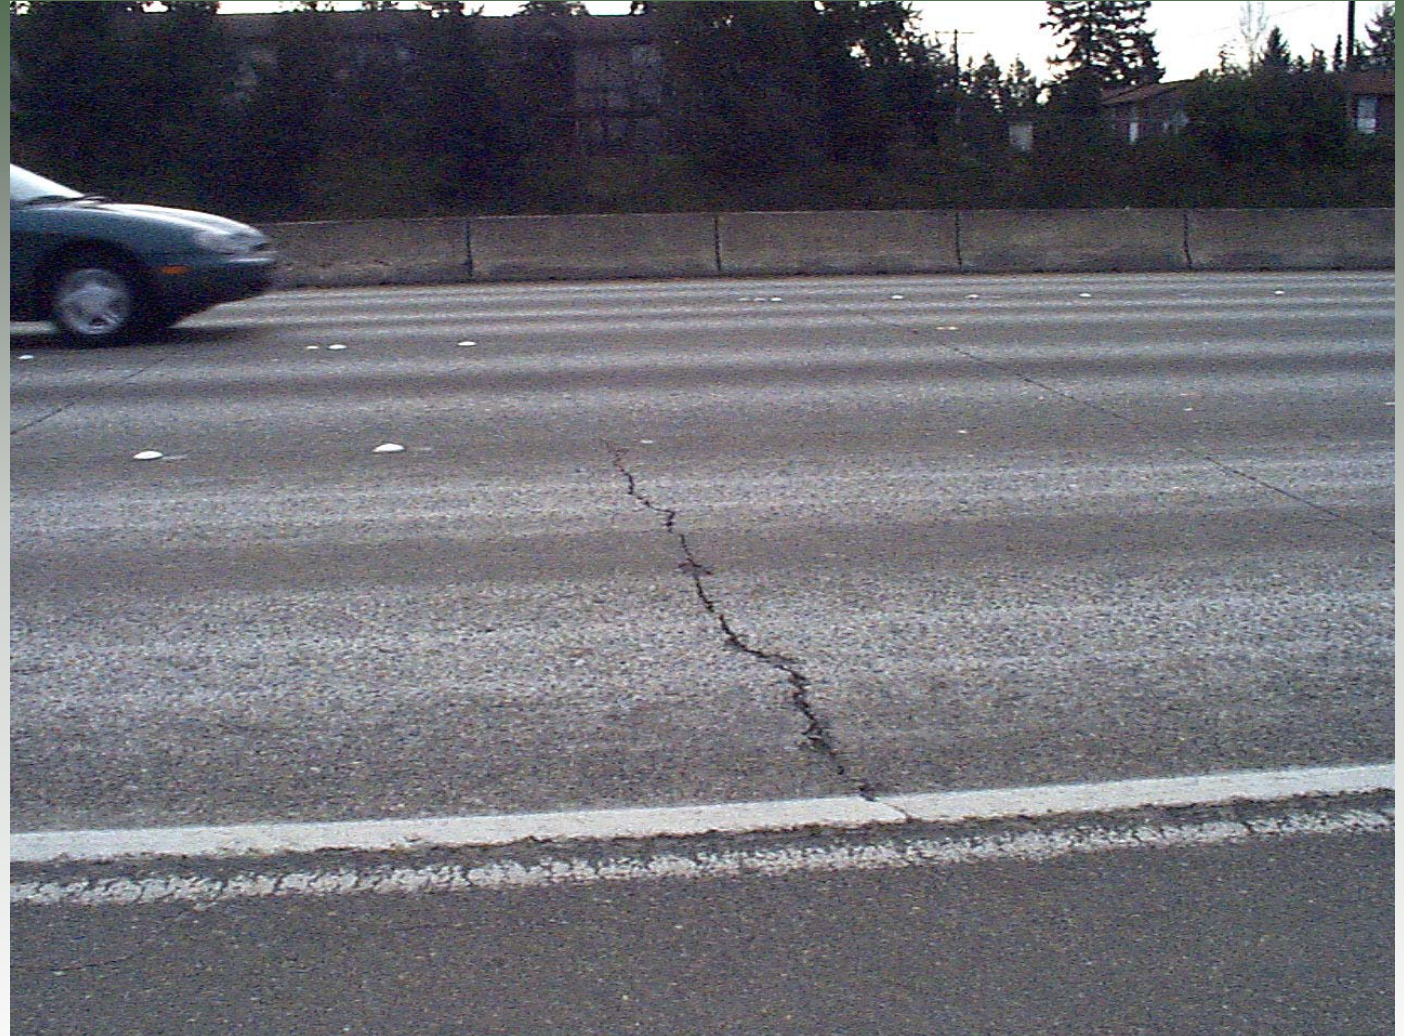
Transverse Cracking

- late sawing
- traffic load fatigue
- slab curl

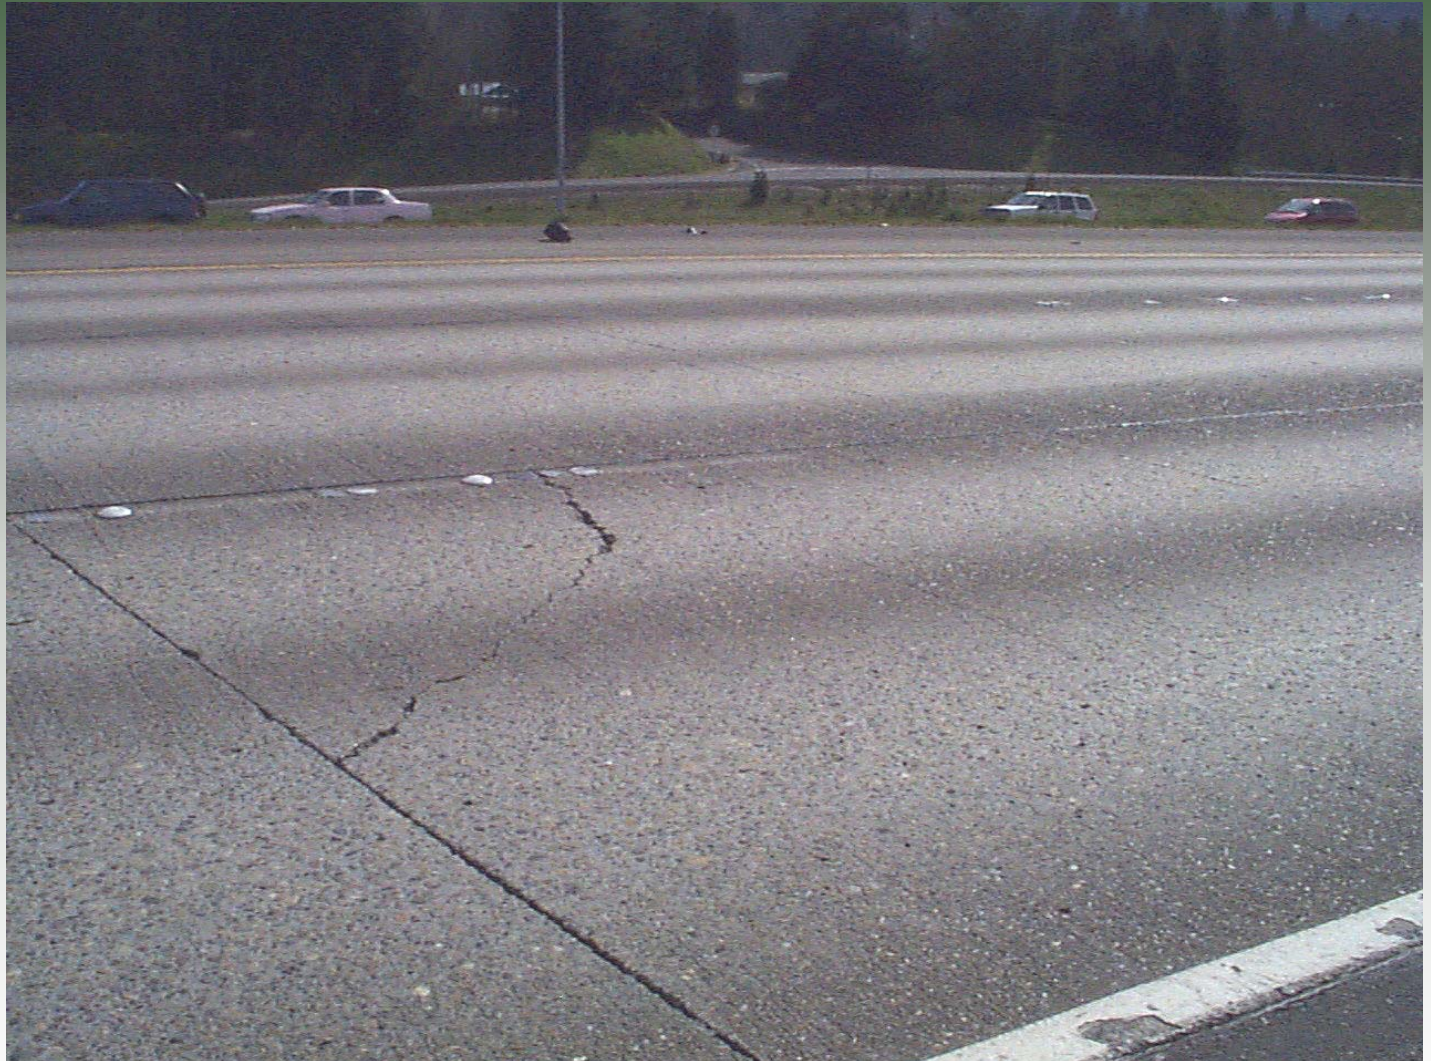
Corner Breaks

- loss of support
- curling and warping

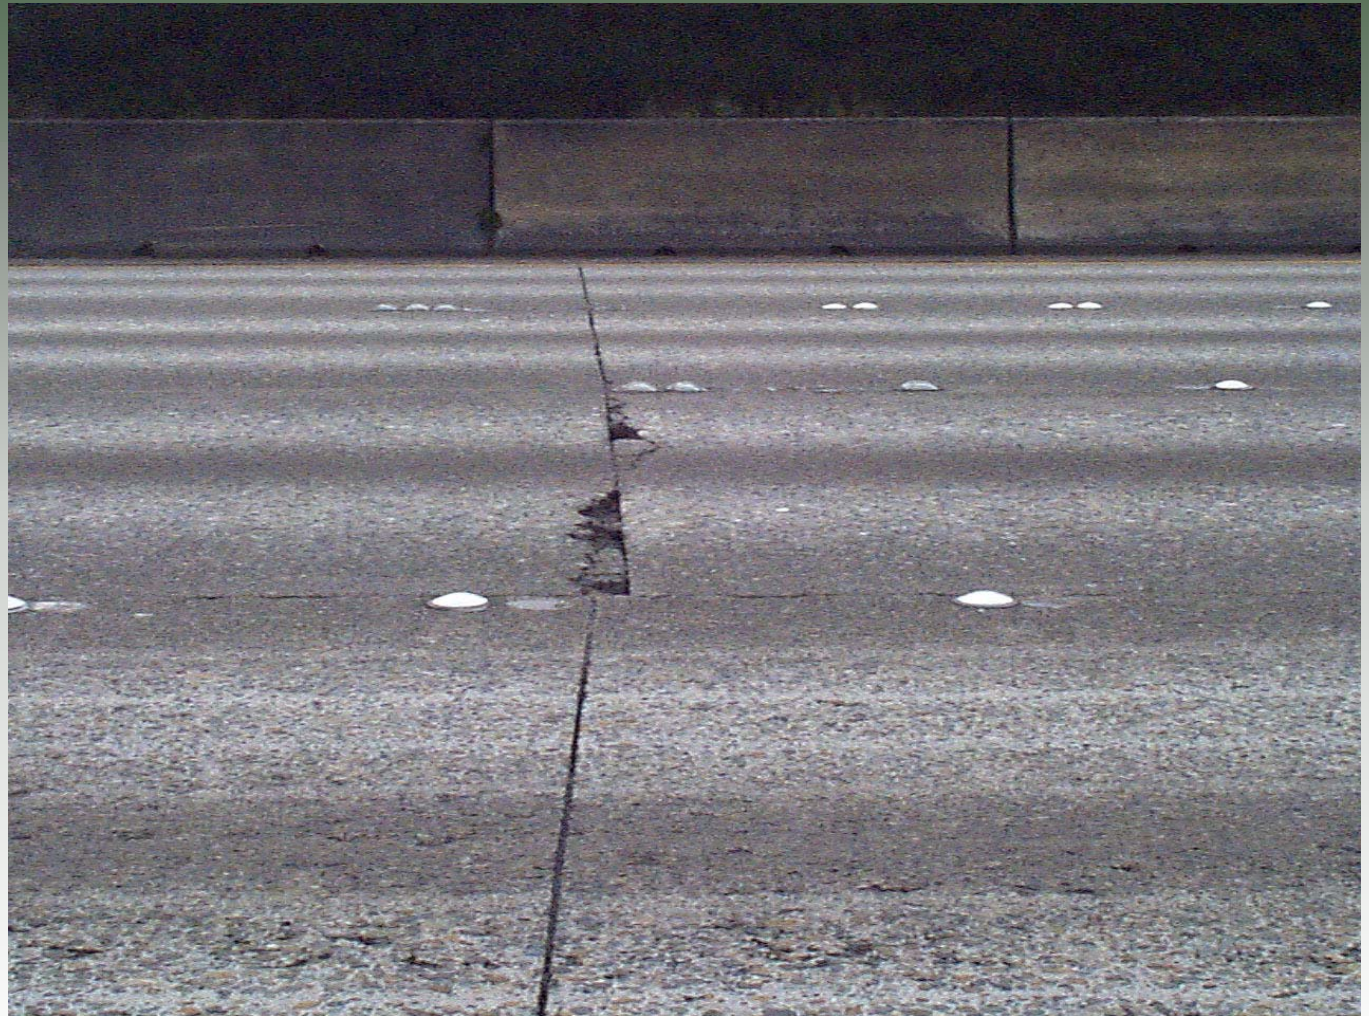
Spalling

- breaking away of concrete from joints and cracks
- typically starts due to incompressible in joint

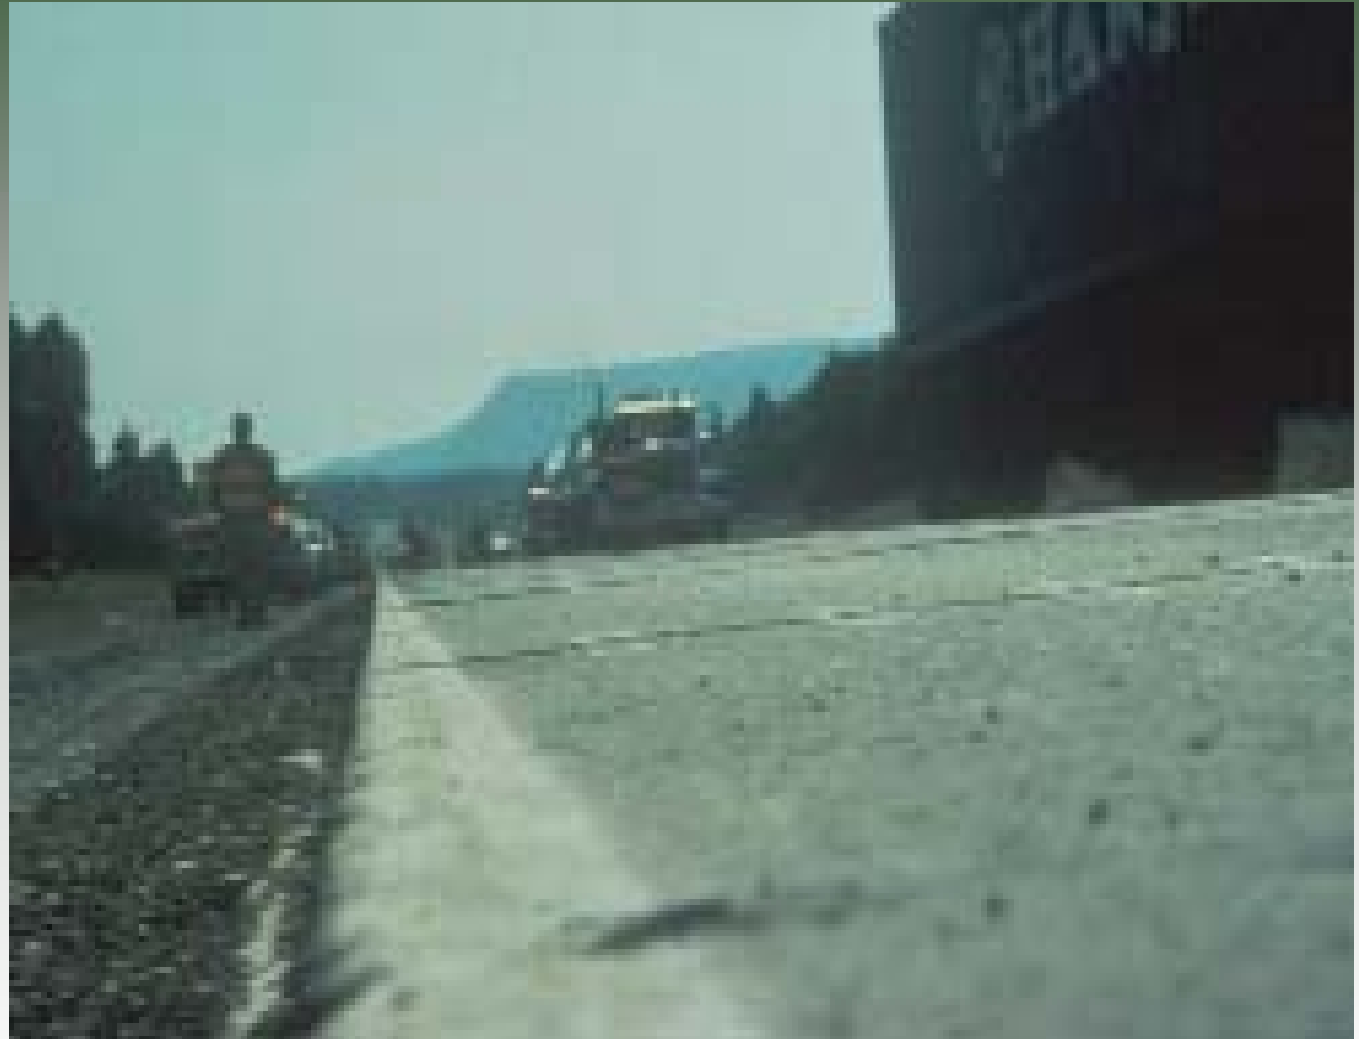
Faulting

- heavy loads
- excess moisture
- fine grained base or subgrade
- load transfer deficiency

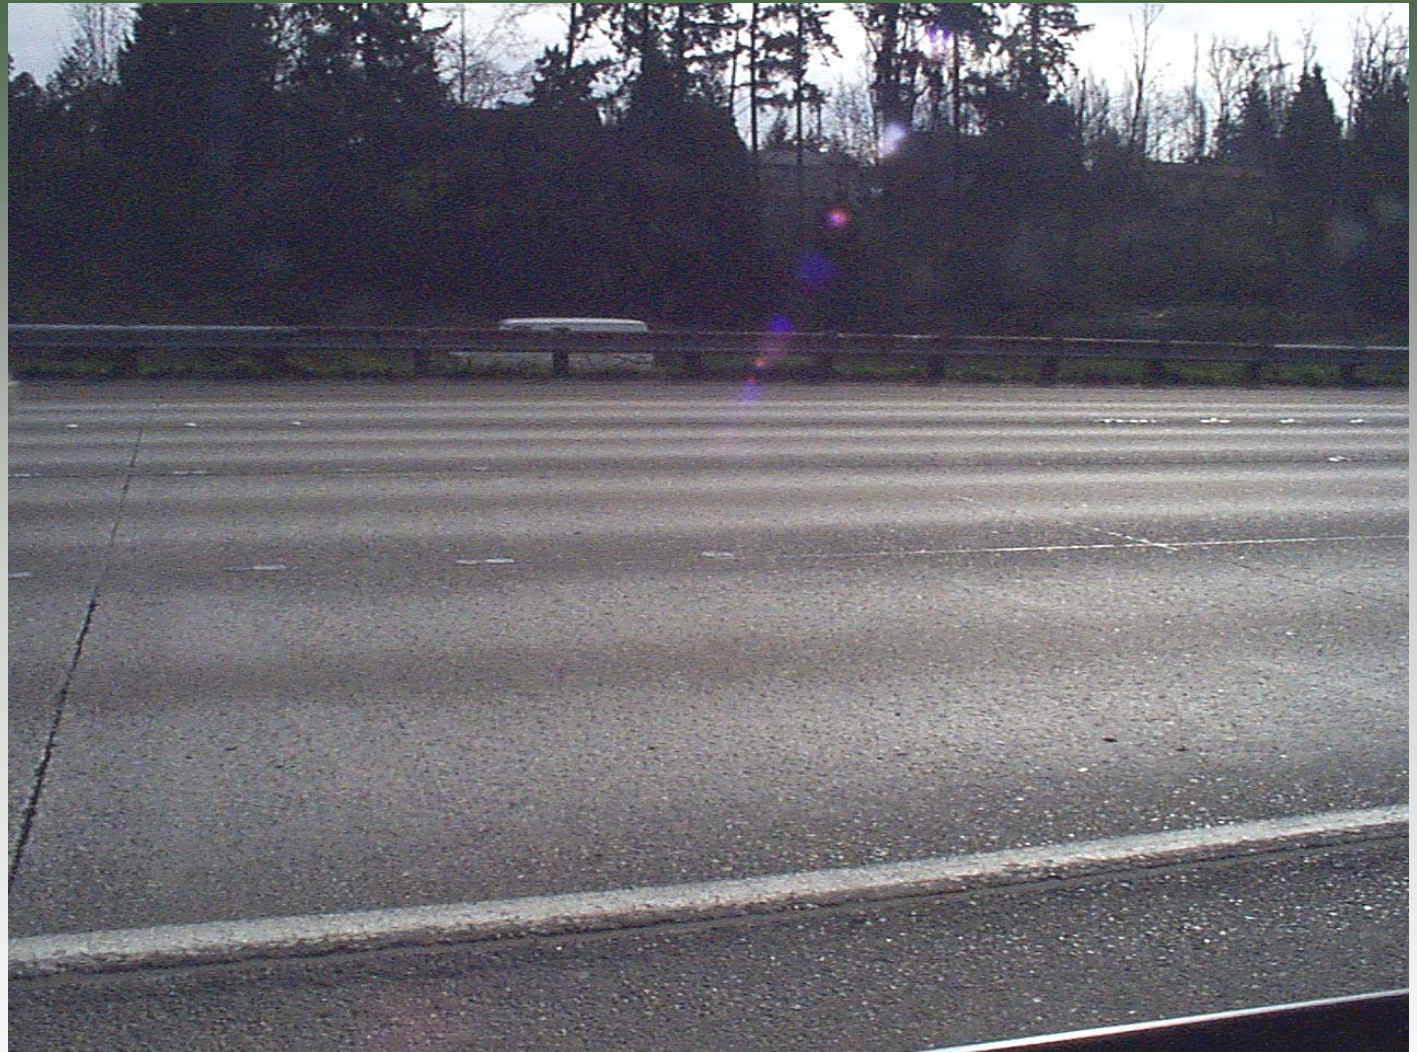
Surface Wear

- studded
tires
- leaves
smooth
polished
surface
- surface
friction

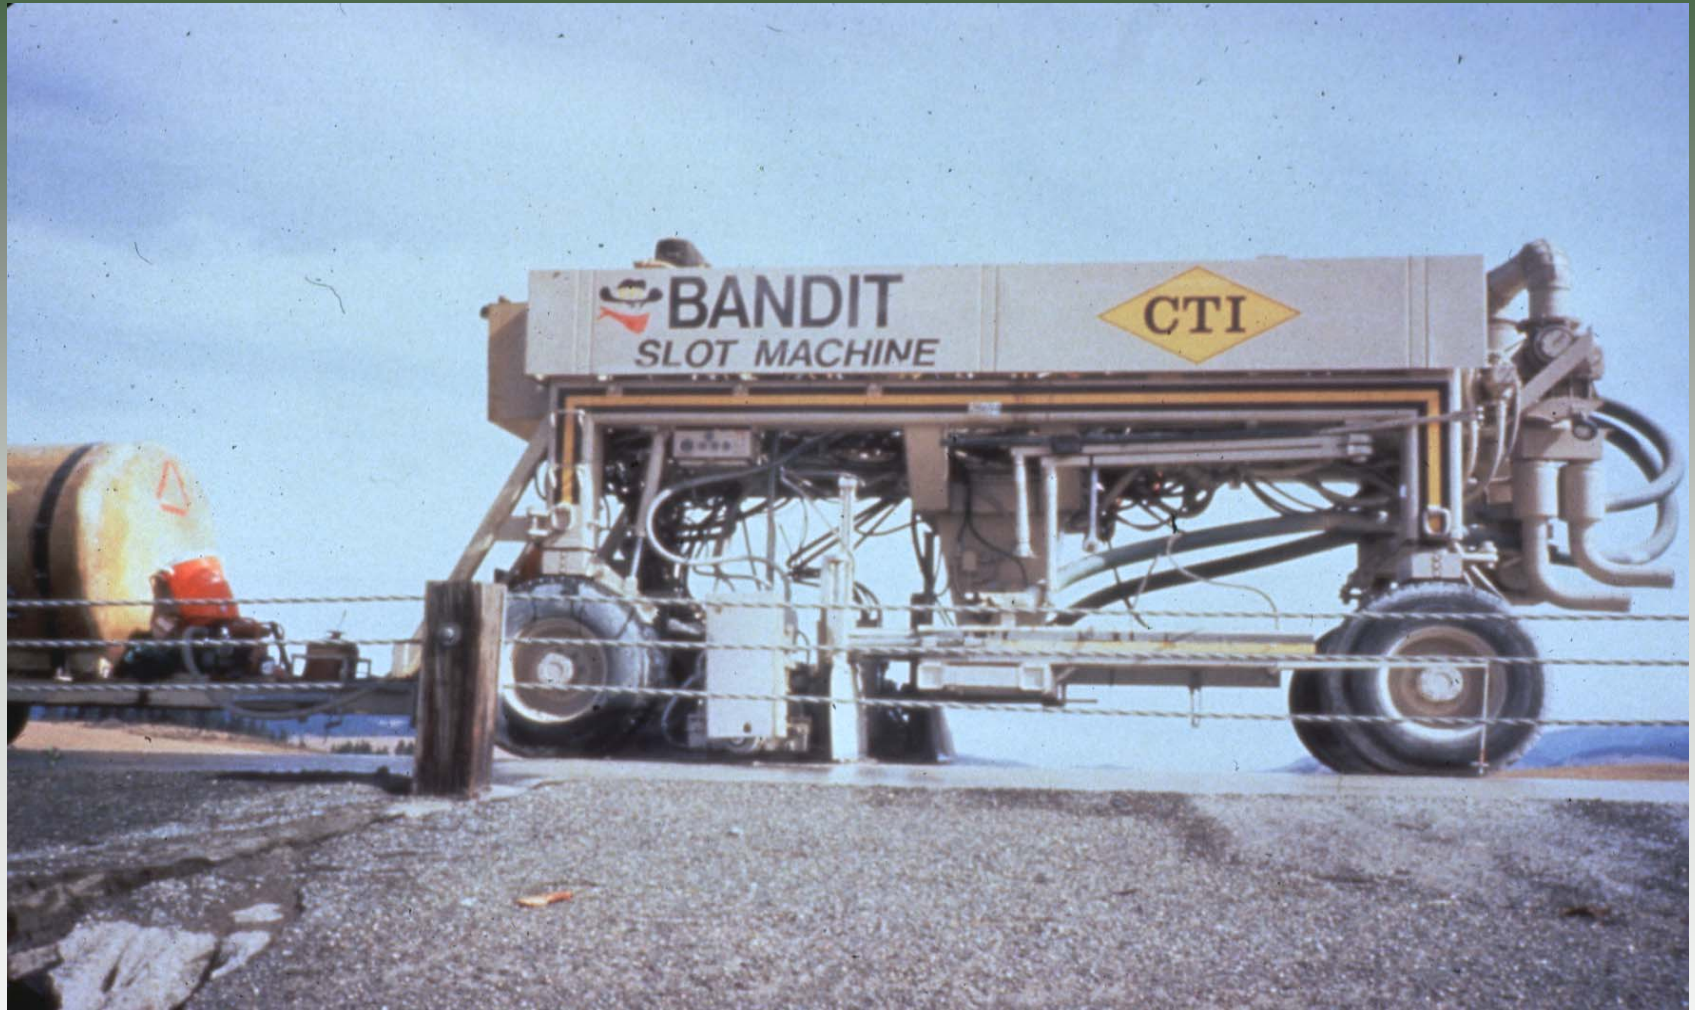
Cutting slots

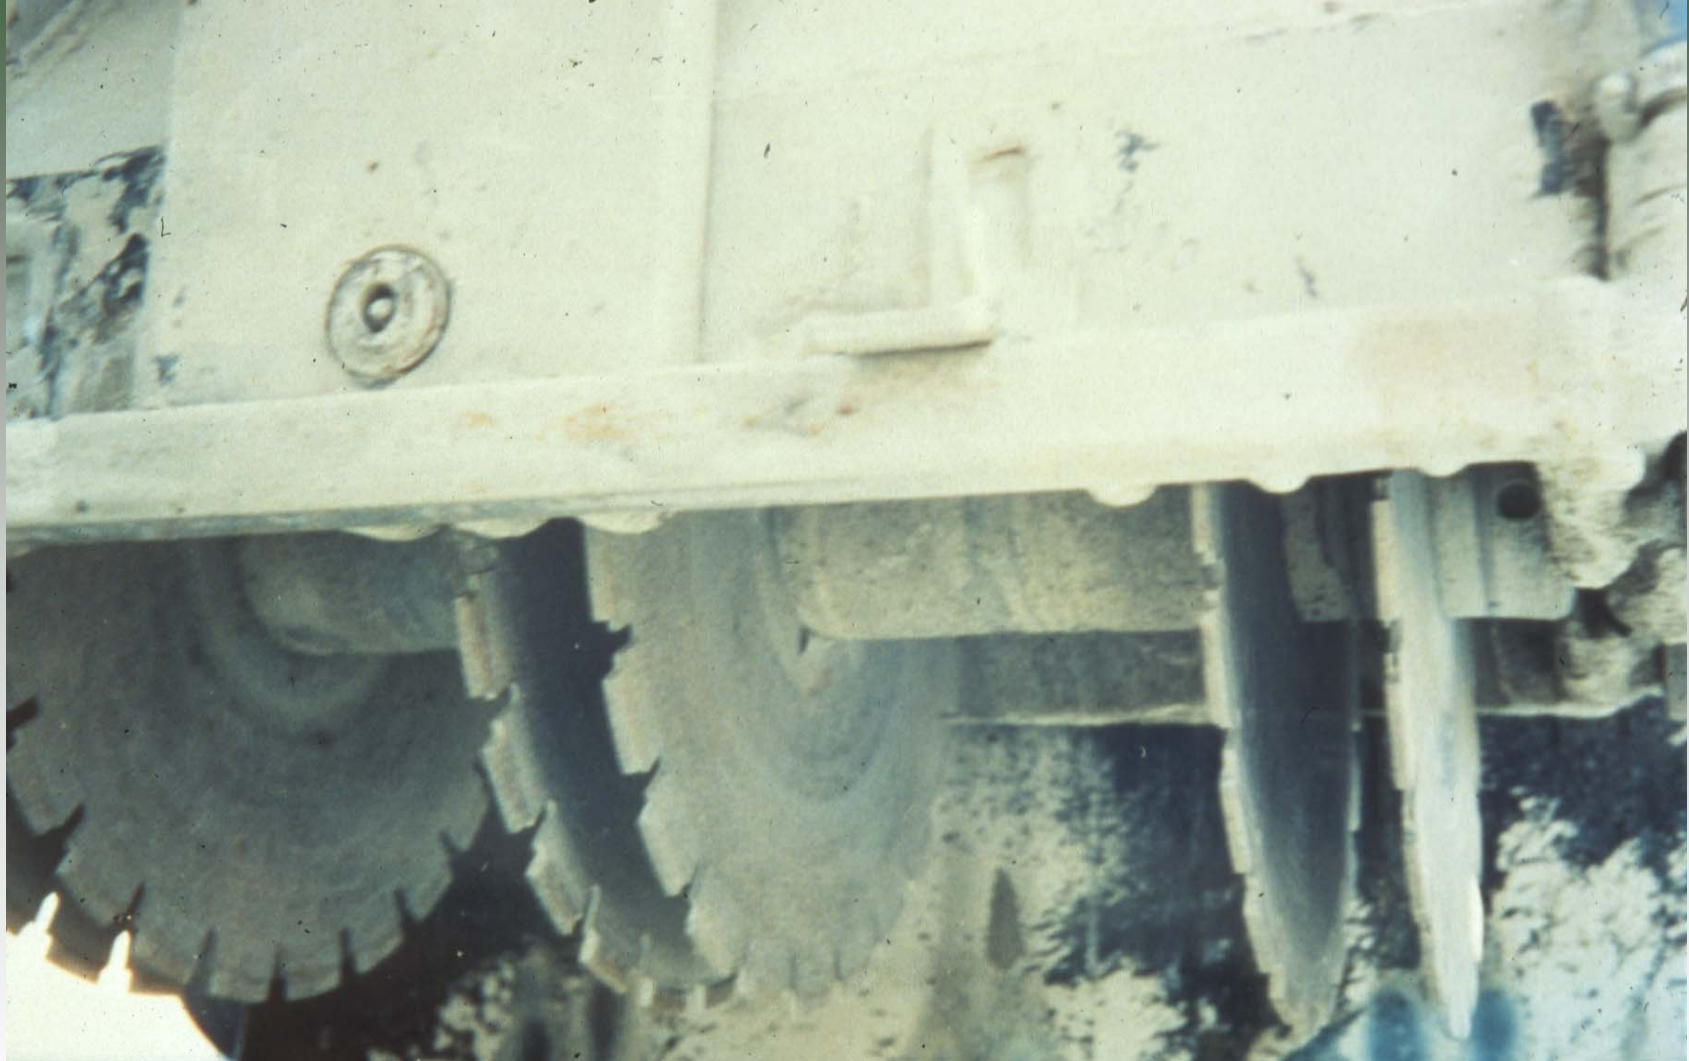
Saw blade placement

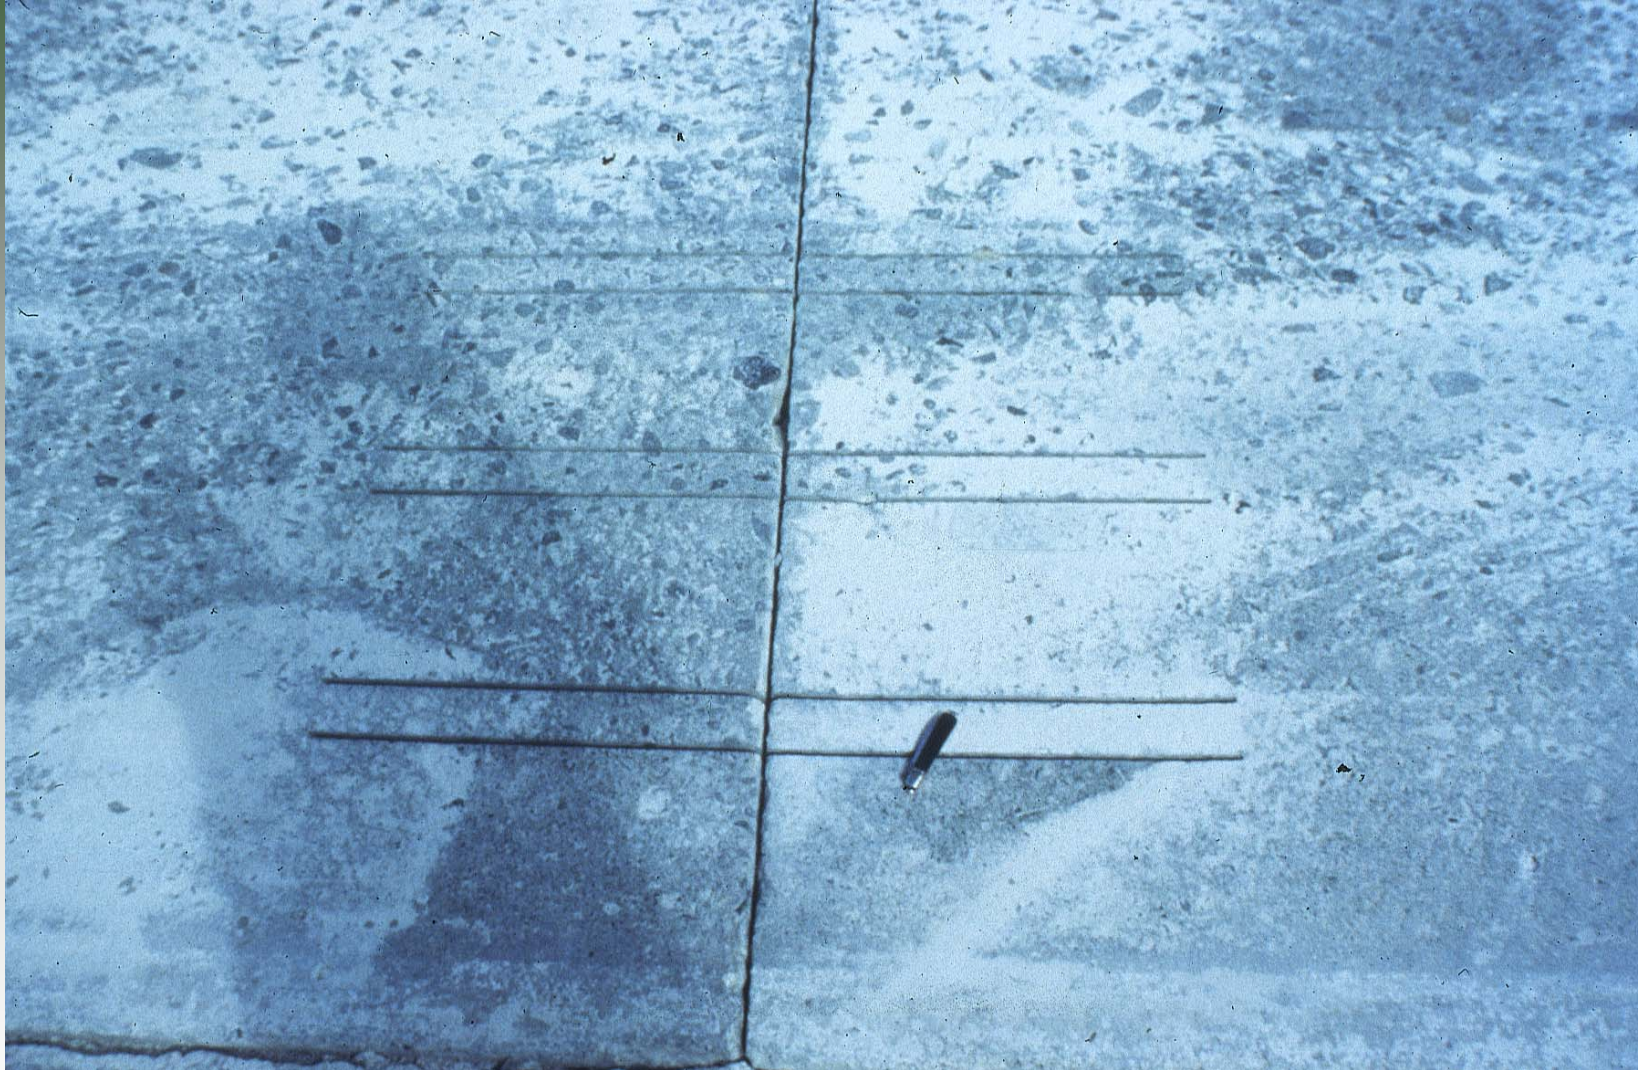
Sawed slots

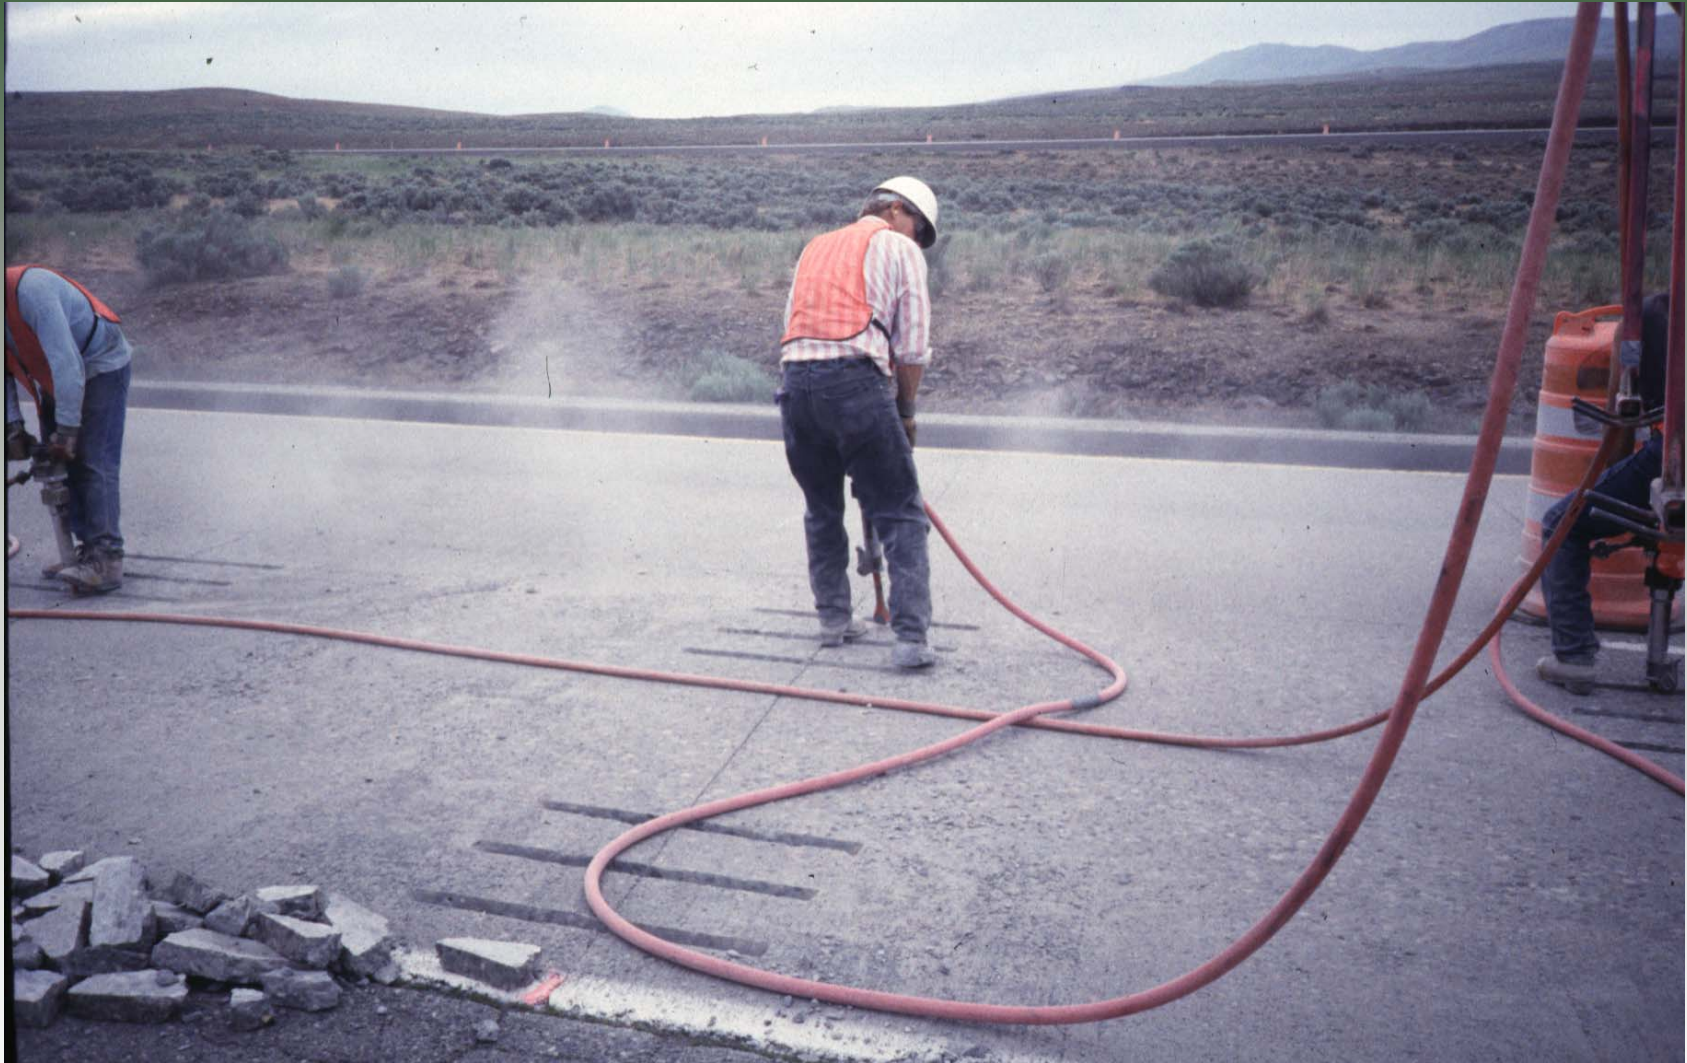
Removing material from slot

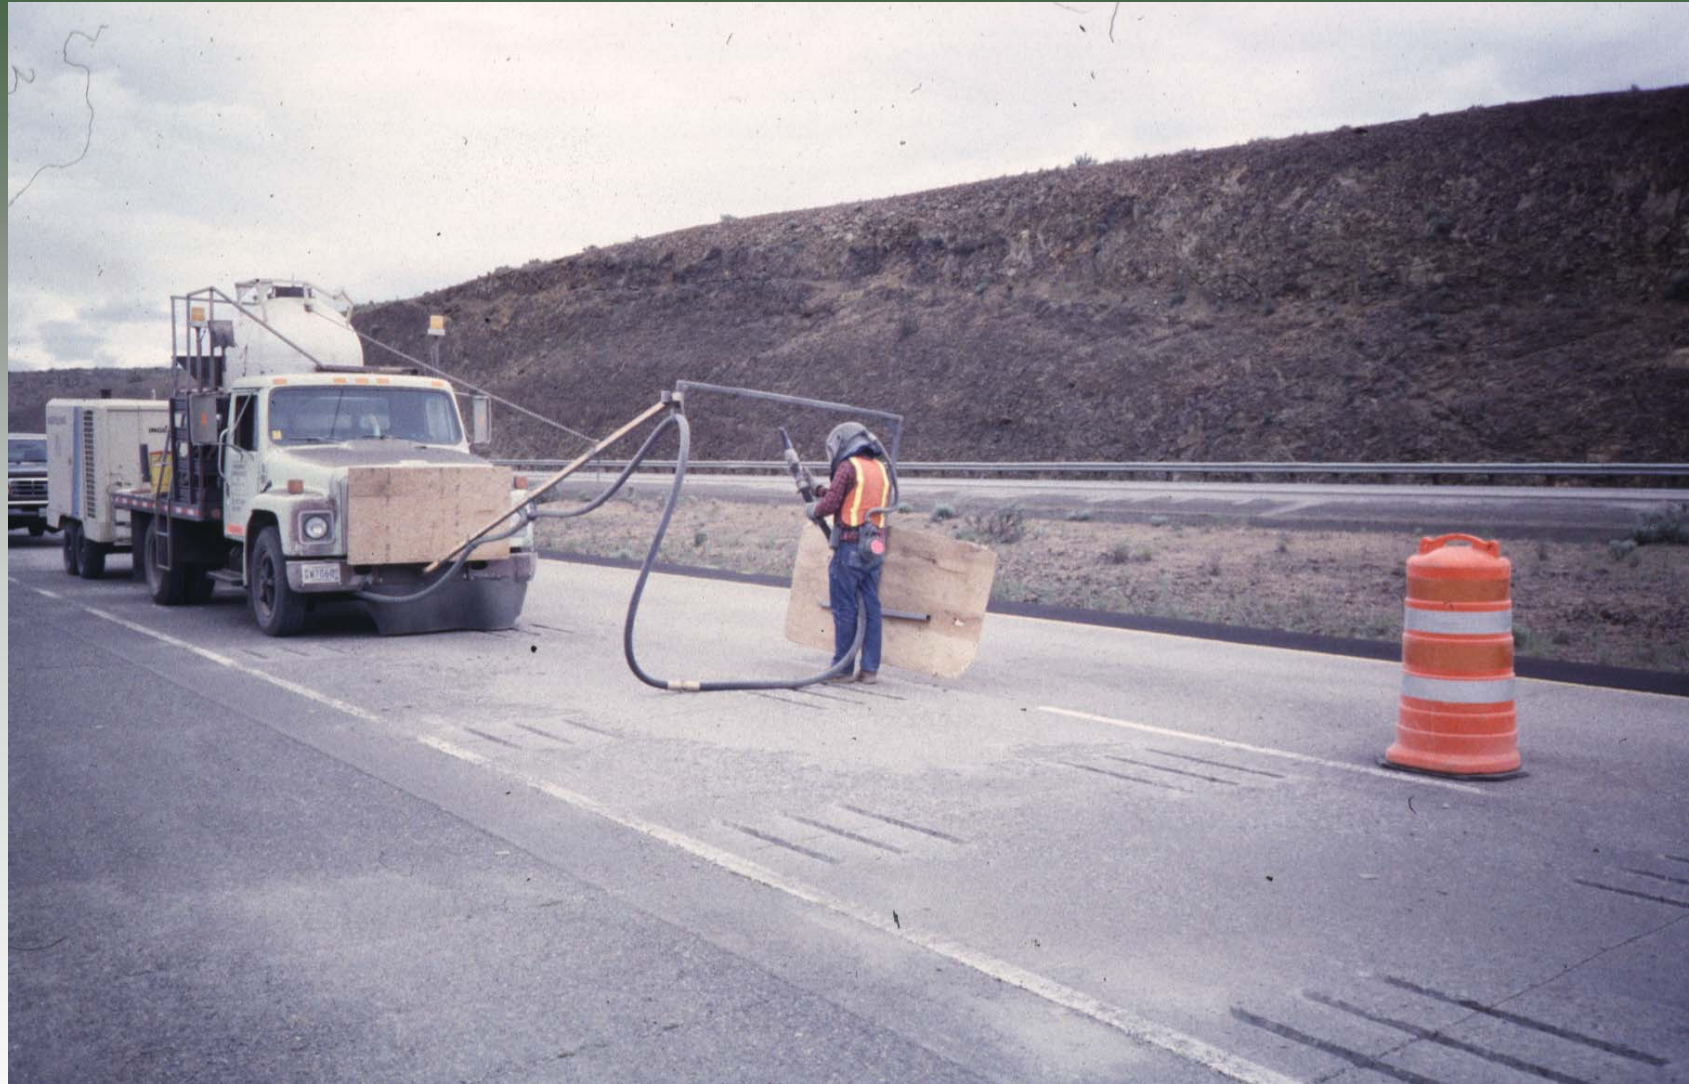
Sand blasting slots

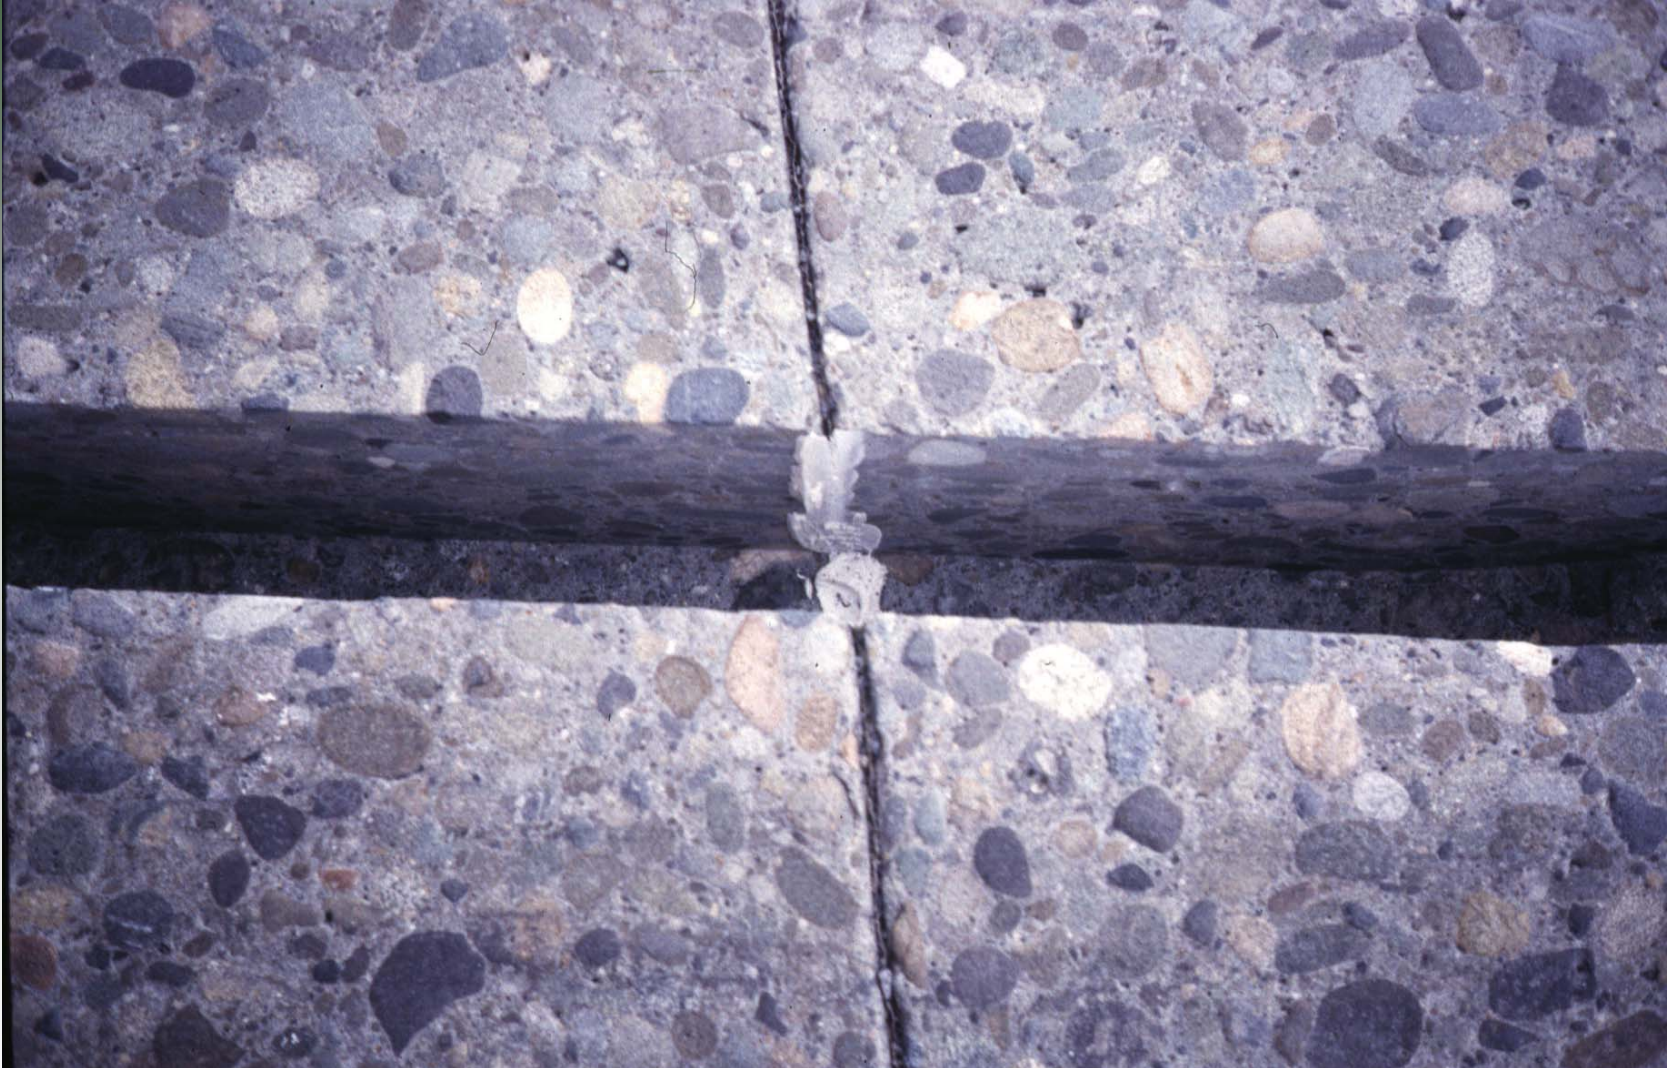
Silicone sealant in joint

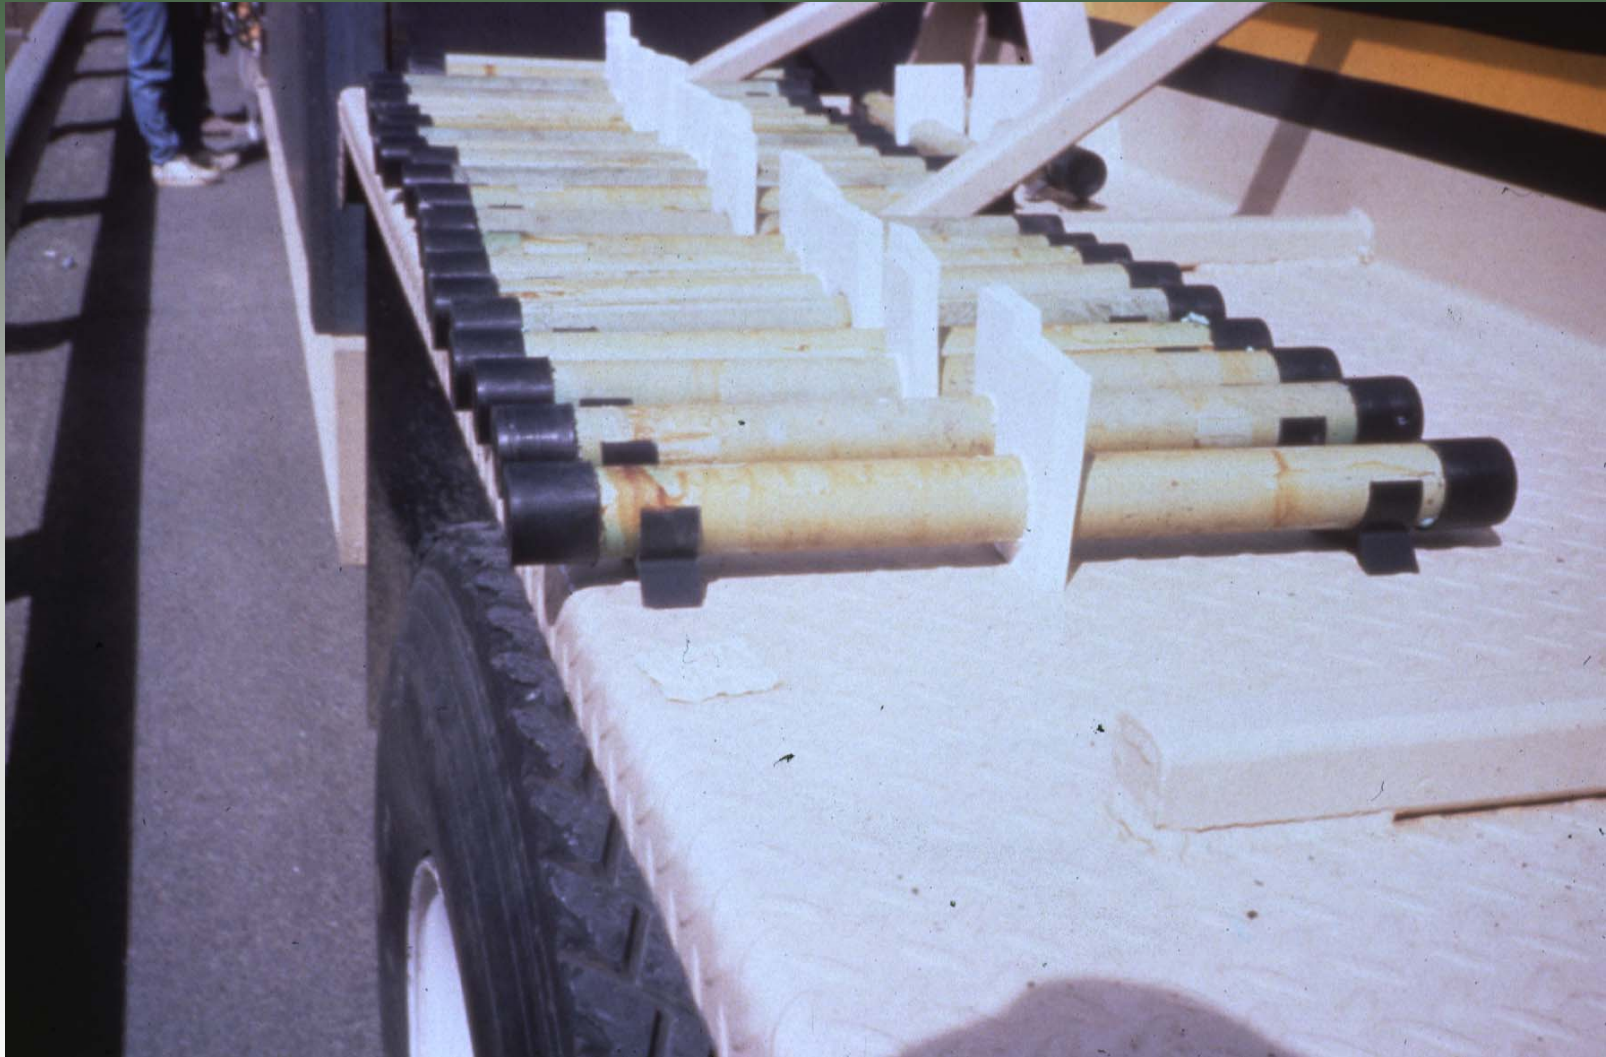
Dowel bars

- ▶ Restore load transfer
- ▶ 1-1/5 inch epoxy coated dowel bars
- ▶ 6 bars per transverse joint or transverse crack
- ▶ Diamond grinding

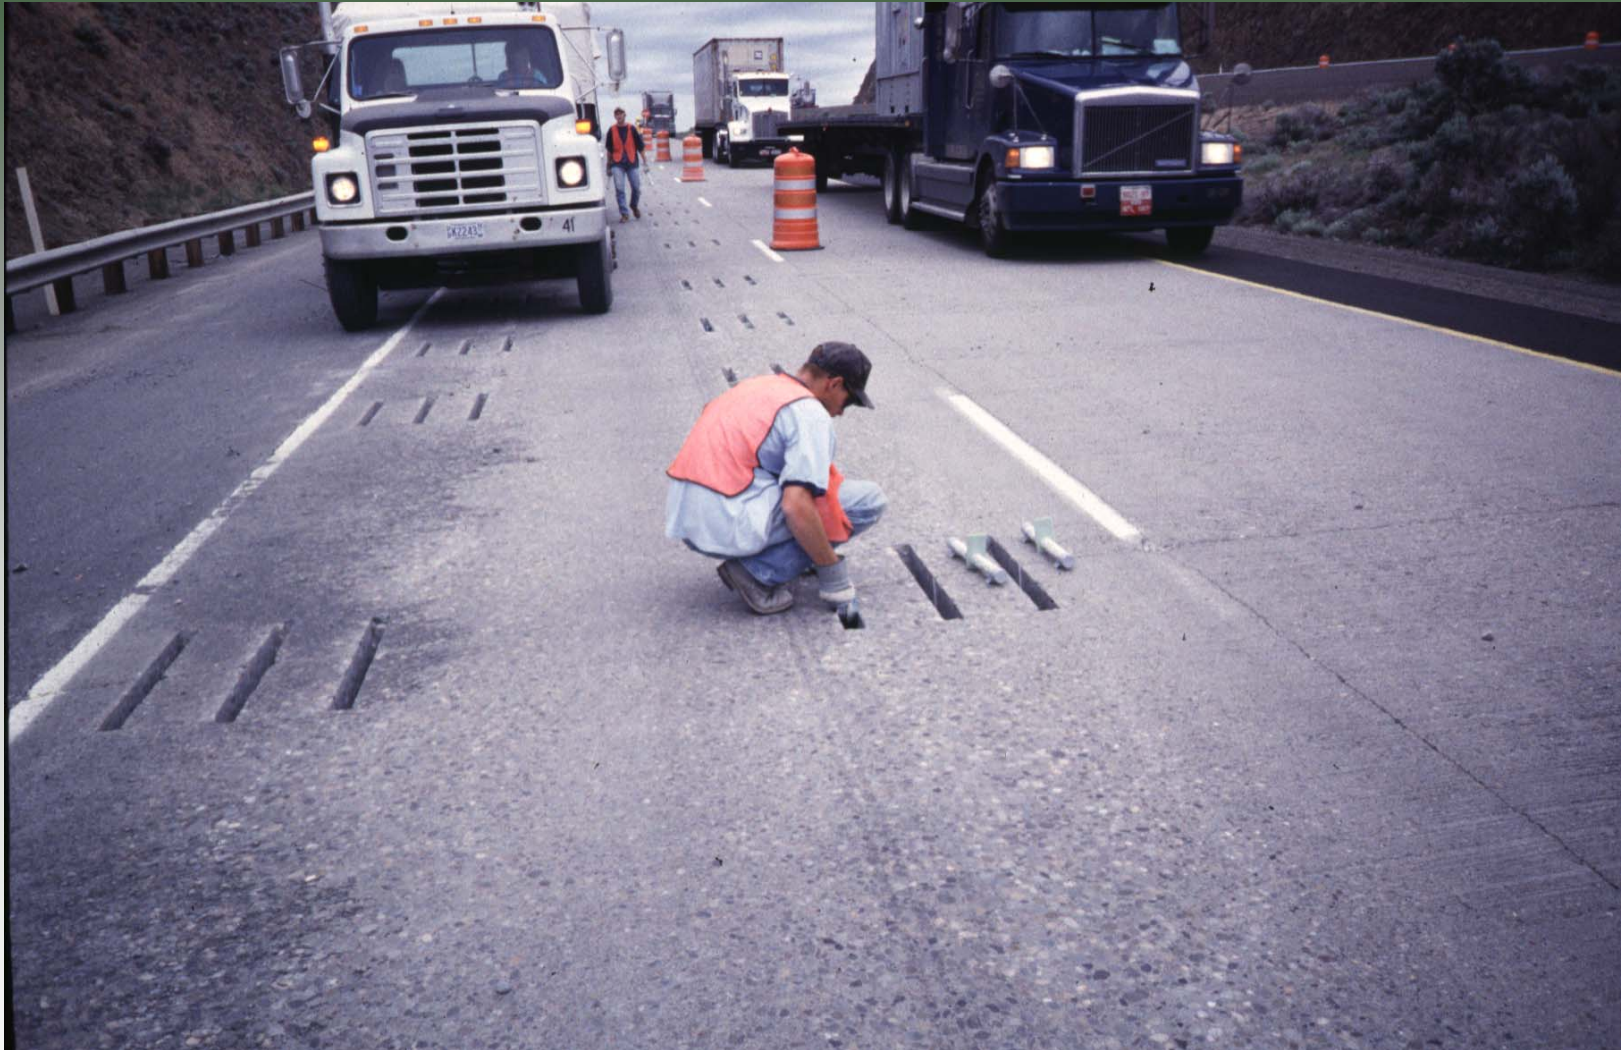
Placing dowel bars in slots
